A Landslide Risk Management Approach for the  
Stillwater to Ngakawau Rail Corridor (SNL96 to 126km)  
in the Lower Buller Gorge, New Zealand

A thesis submitted in partial fulfilment of  
the requirements for the degree of

Master of Science in Hazard and Disaster Management

**UNIVERSITY OF CANTERBURY**  
**2012**

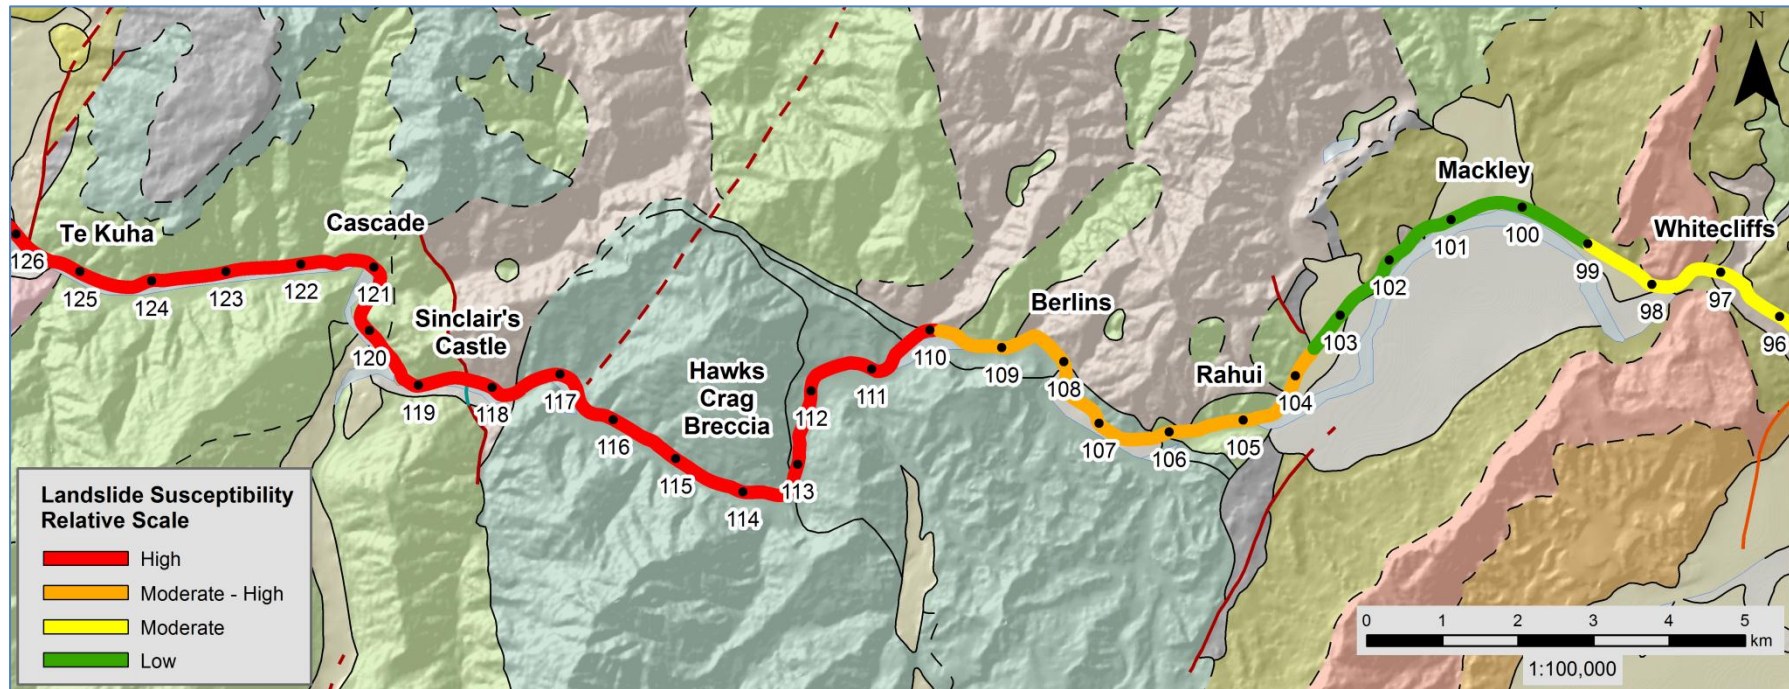
Small sections of rail corridor within ‘High’ and ‘Moderate - High’ zones will have lower susceptibility, but have not been separated at the map scale presented in Figure 4.4. The present map is based on desktop information only, and can be refined by site-specific investigation as at Te Kuha between SNL124 and 126km (Chapter 7).

**Figure 4.4: Qualitative landslide susceptibility zonation map. Metrage locations (SNL km) and main location references are overlain.**

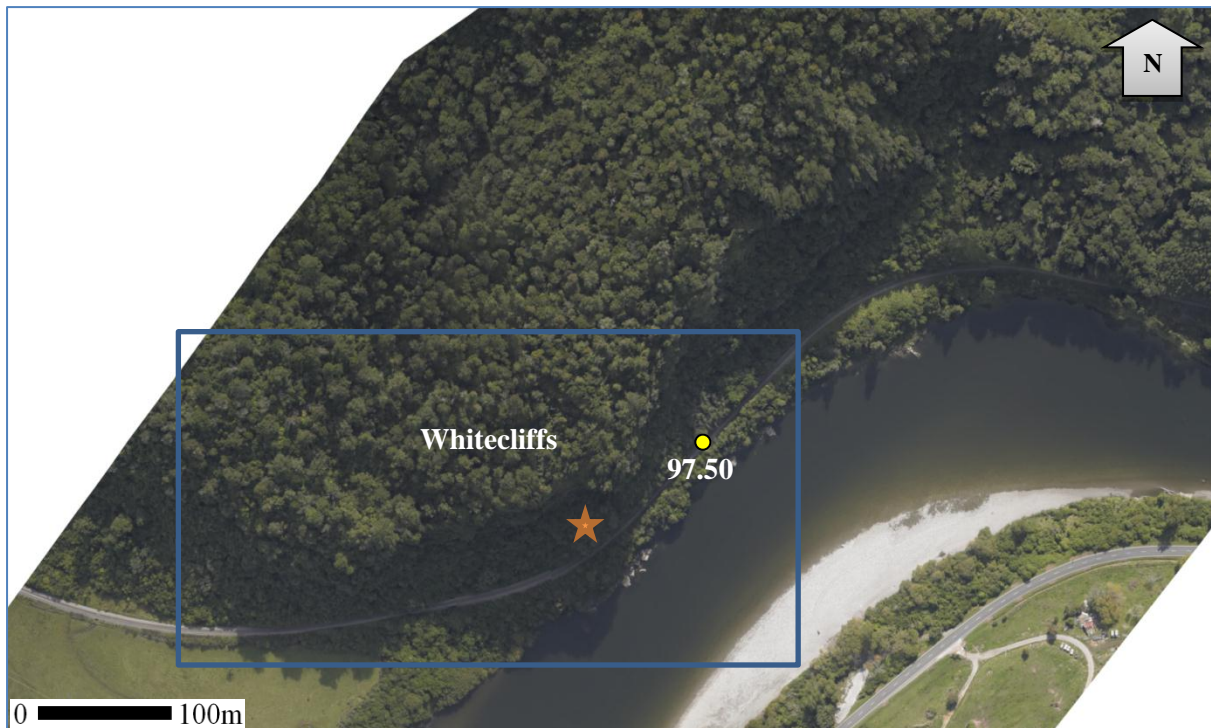
**Figure 6.1: Aerial view of Whitecliffs showing the area adopted for the risk assessment and SNL97.50km metrage location (aerial base from NZ Aerial Mapping Ltd). Star indicates the location of a very large ( $\sim 20,000\text{m}^3$ ) displaced limestone block immediately adjacent to the rail corridor around SNL97.60km.**

The top of the near vertical cliffs above the rail is at an elevation of 140m amsl, with the rail alignment around 55m amsl. Widely spaced ( $>10\text{m}$ ) sub-vertical fractures are visible in the cliff-face, both parallel to and normal to the face aligned roughly parallel to the rail (Chapter 3, Figures 3.1 and 3.2). Bedding planes, numerous ledges and vegetation are visible down the vertical profile (Chapter 1, Figure 1.6). A well-established talus apron is present from around 75m amsl, sloping on average at  $35^\circ$  to  $\sim 50^\circ$  down to the rail alignment. The very large displaced block (in the order of  $20,000\text{m}^3$ ) immediately adjacent to the rail at SNL97.60km provides an indication of the scale of previous failures, and its location is indicated by the star on Figure 6.1.

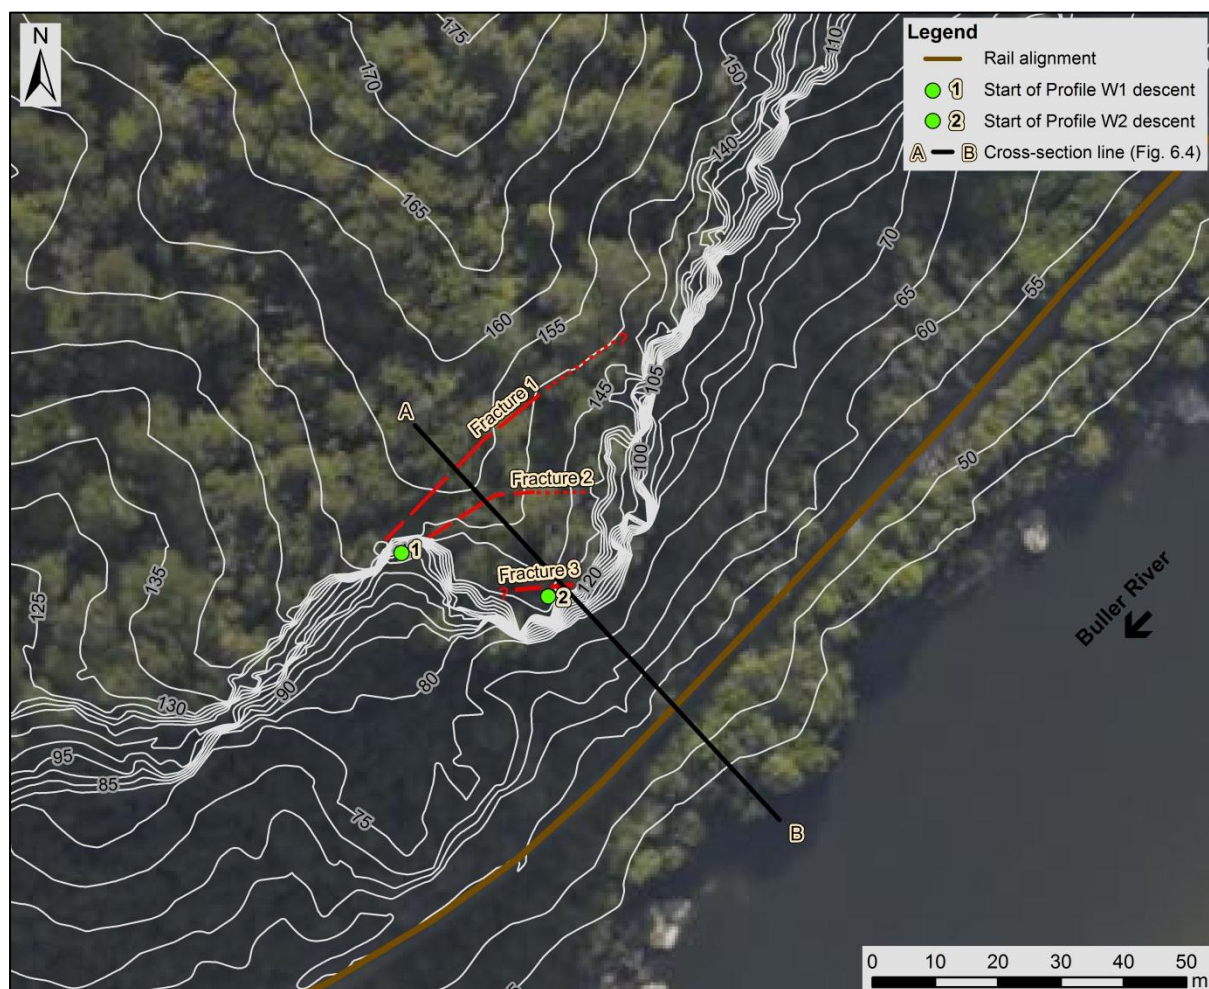
**Figure 6.4: Fractures mapped at the top of Whitecliffs and start of Profiles W1 and W2**

The fractures trend generally in the same direction (southwest to east-northeast). GPS coordinates of the fracture locations were taken and this data added into the site model for Whitecliffs using ArcGIS software. Measurements of the open fractures are summarised in Table 6.1, and extrapolated from marked locations on Figure 6.4. A representative cross-section of the fractures and cliff-face profile is provided on Figure 6.5, and its location is shown on Figure 6.4.

Reference*	Description and measurements
<b>Fracture 1</b>	<ul style="list-style-type: none"> <li>Western end: measured for 16m, open horizontally to a maximum of 1.4m, decreasing to between 0.3-0.6m towards the east.</li> <li>The fracture extends laterally from a true bearing of 040 (north-east), changing to a bearing of 070 (east-northeast) until definition is lost as the ground slope increases and material on the downslope side of the fracture has dropped away.</li> <li>Material has infilled the fracture but it is still open down to a maximum of 1.5m below ground level (western end).</li> <li>Vertical displacement is less than 0.2m, downthrown towards the south/southeast.</li> </ul>

Reference*	Description and measurements
<b>Fracture 2</b>	<ul style="list-style-type: none"> <li>Measured for 8m, stepping from a bearing of 060 at the western end to around 090 at the eastern end.</li> <li>Open horizontally to a maximum of 1.3m, decreasing to 0.6m towards the east.</li> <li>Maximum vertical displacement was 0.9m, downthrown towards the south. Infilling has occurred with the measured fracture depth ranging between 0.4m and 0.8m from the downthrown side of the fracture.</li> </ul>
<b>Fracture 3</b>	<ul style="list-style-type: none"> <li>Measured for 9m, orientated east to west.</li> <li>Horizontal opening decreases towards the east (from 0.9m to 0.4m).</li> <li>Maximum measured vertical displacement of 1.2m, downthrown side towards the south.</li> <li>Access to the western extent of Fracture 3 was not possible.</li> </ul>
* Refer Figure 6.4 for spatial distribution

There is no evidence at the top of Whitecliffs to indicate any active movement of the displaced limestone blocks and fracture sets, based on vegetation cover, the degree of infilling of the open fractures, and absence of slab failures on the sides of the open fractures. This observation is supported by measurements recorded by KiwiRail staff of metal pins that are located across the western end of Fractures 1 and 3 (Appendix 1.3). The vertical offsets across each fracture show the maximum downthrown extent increasing towards the cliff-face from 0.2m (Fracture 1) to 1.2m (Fracture 3). The tapering observed in opening widths of the fractures, to penetrative joints at greater depth below the ground surface, does also suggest past toppling movements (Figures 6.4 and 6.5).

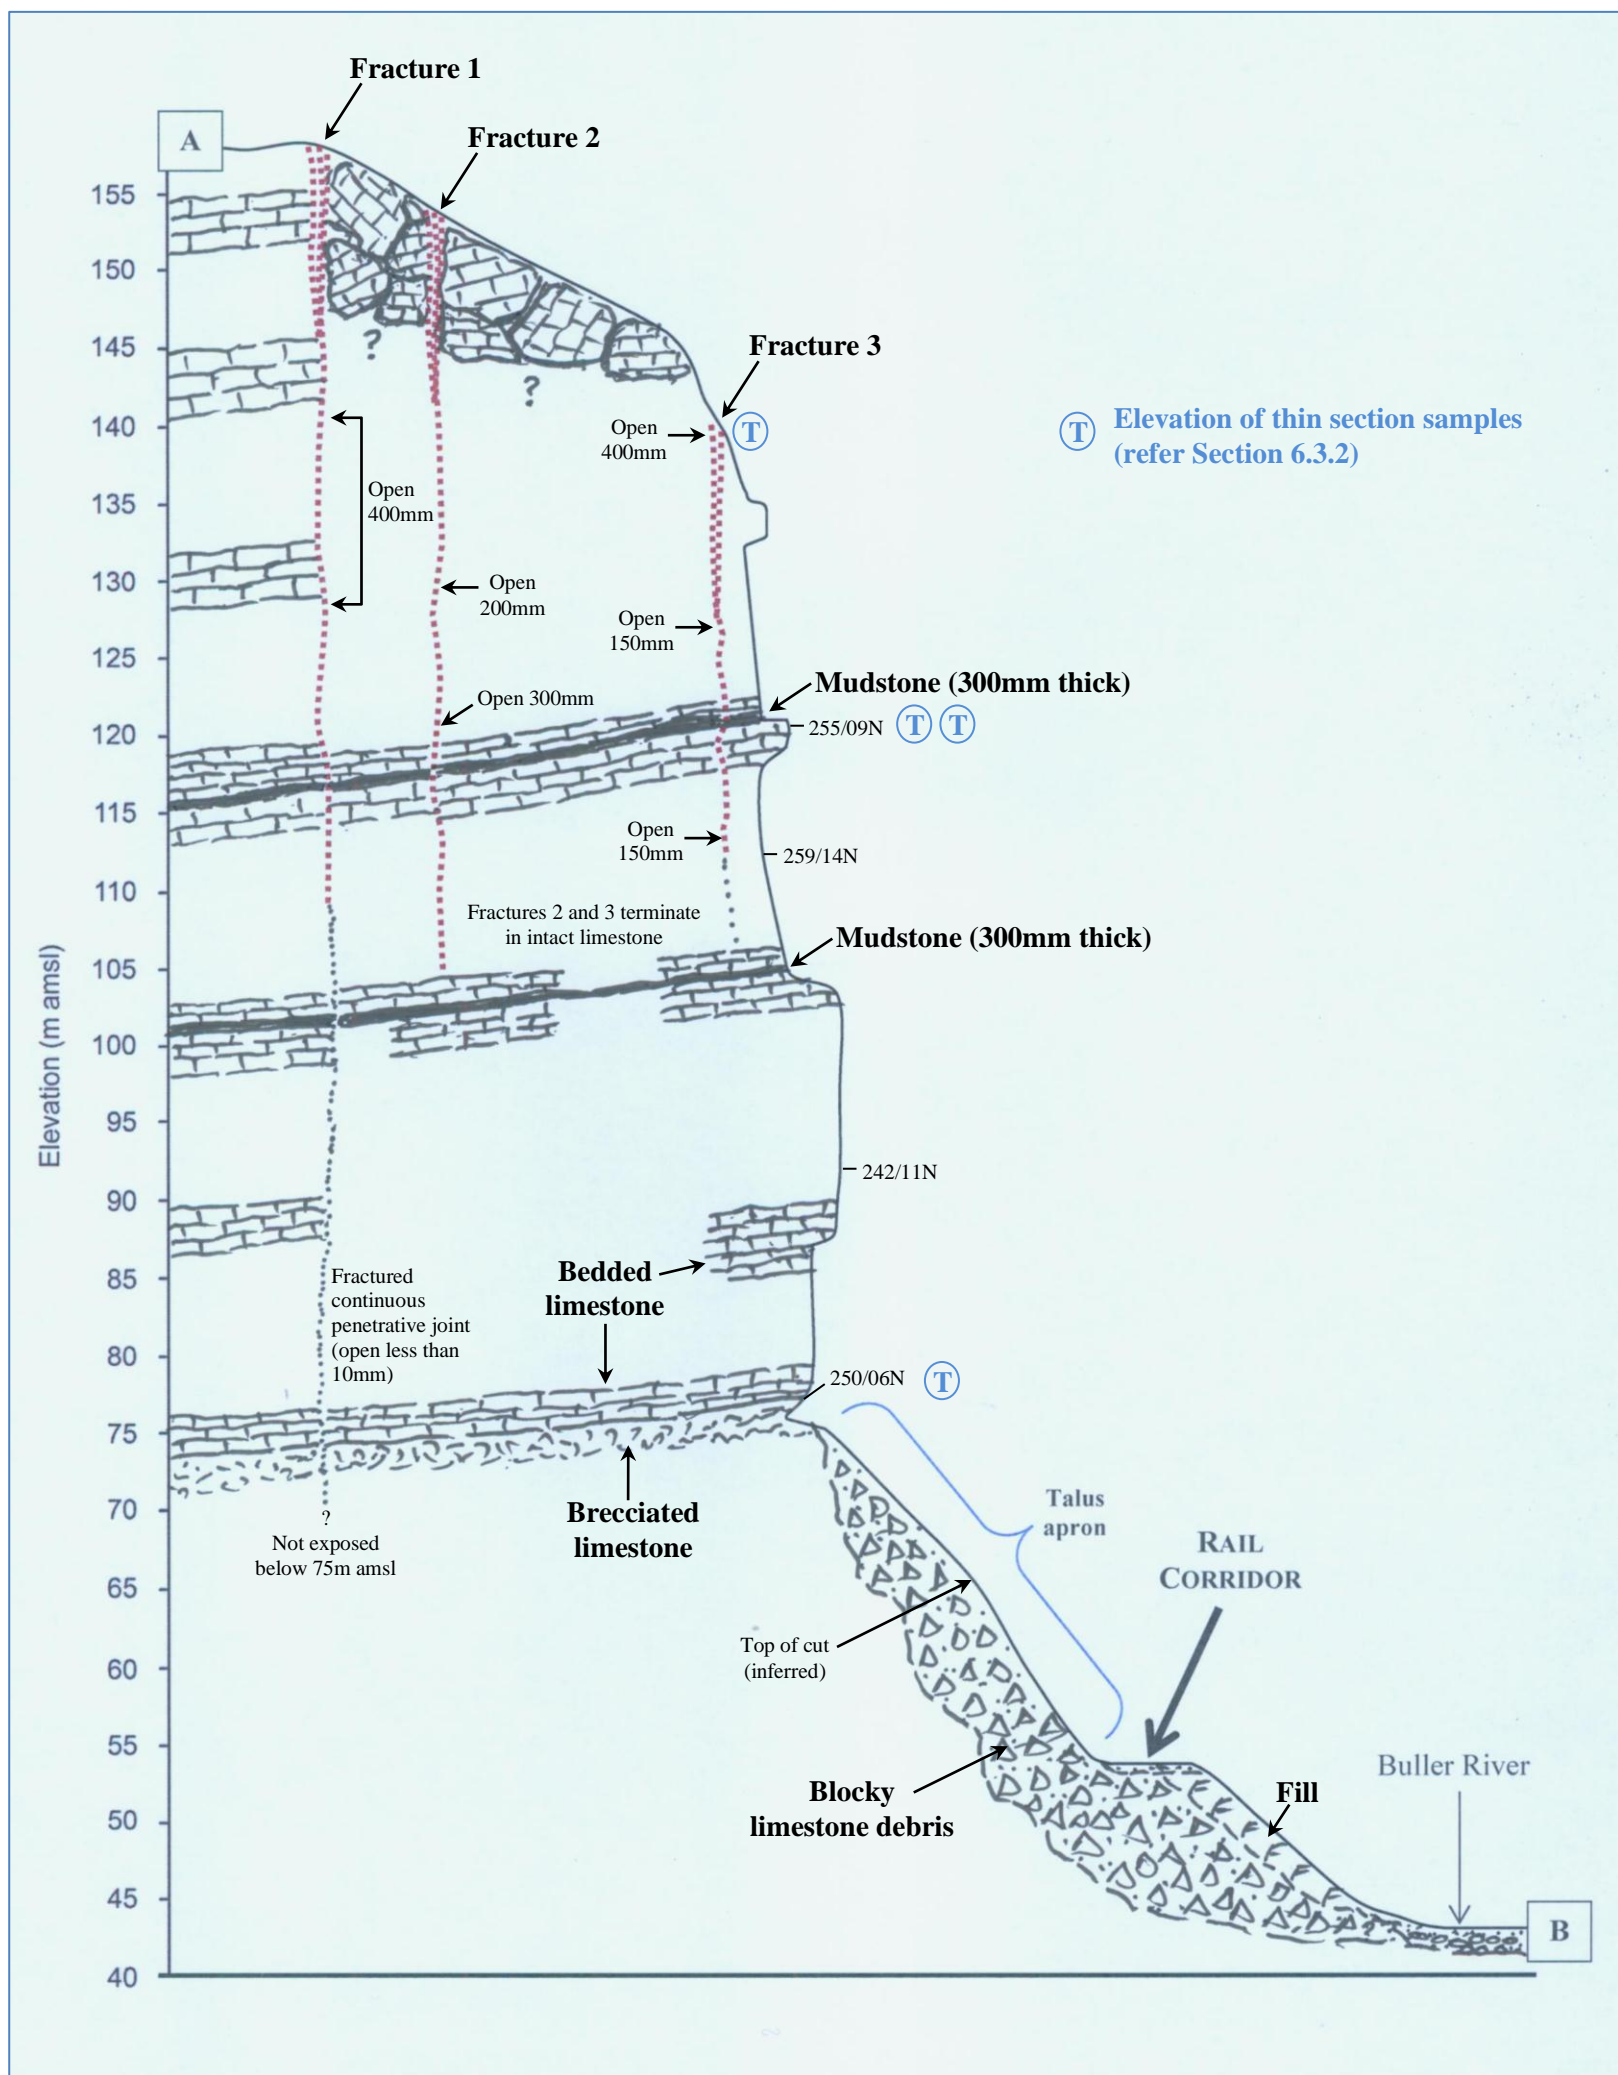
**Figure 6.5: Representative cross-section of the Whitecliffs profile (location of section A–B shown on Figure 6.4).**

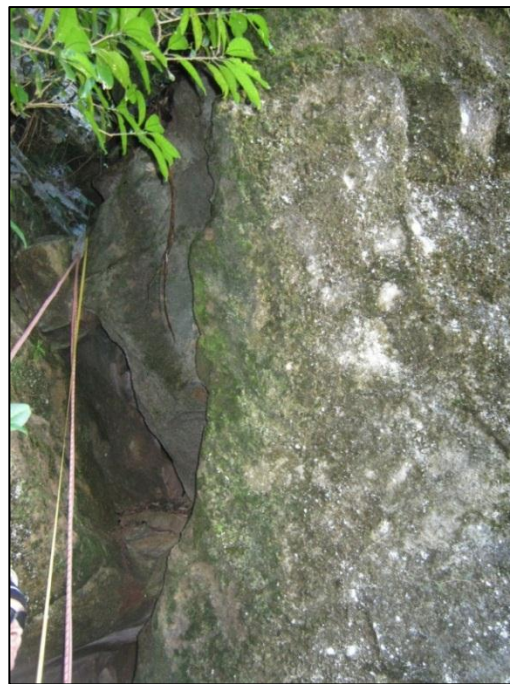
- Unvegetated rock was exposed from the start of the descent, near the monitoring pins (140m, Figure 6.6) to ~98m.
- Loose (detached) limestone blocks with volumes exceeding 10m<sup>3</sup> were predominant between 140m and 128m. The western extent of the detached blocks was bounded by Fracture 1 (Figure 6.7).

**Figure 6.7:** View looking up from  $\sim 135\text{m}$  elevation during Profile W1 descent showing detached block on right-hand side of photograph and massive, highly indurated limestone.

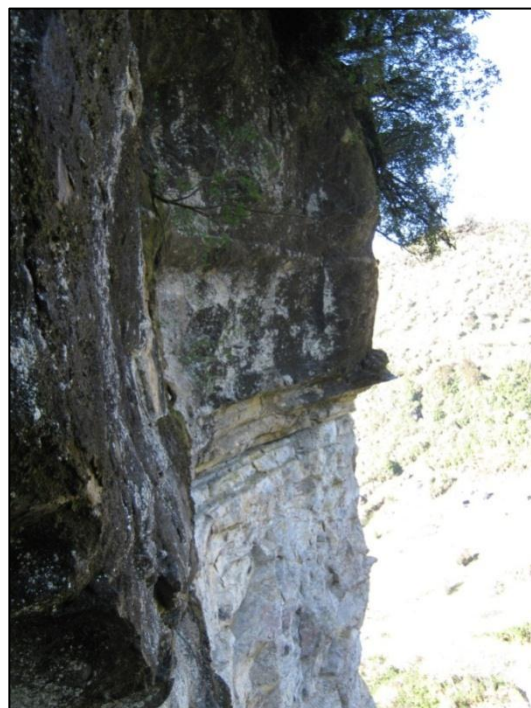
- The first obvious lithological change down the main cliff-face below the detached blocks was reported at 125m (based on the presence of bedding planes, spaced at ~1m). A bedding strike and dip measurement was not possible at this location but the strata was noted as dipping northwards, back into the cliff-face at a shallow angle, as evident in Figure 6.9. The limestone was still very well indurated.

**Figure 6.9:** View looking east from  $\sim 125\text{m}$  elevation during Profile W1 descent. Bedding dips back into the face (north) at a shallow angle ( $<15^\circ$ ).

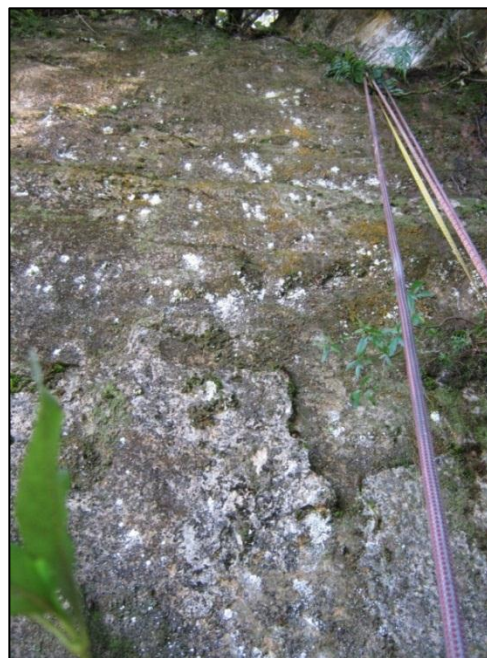
**Figure 6.11:** Massive, very well indurated limestone, looking back up at the first 6m of the descent.

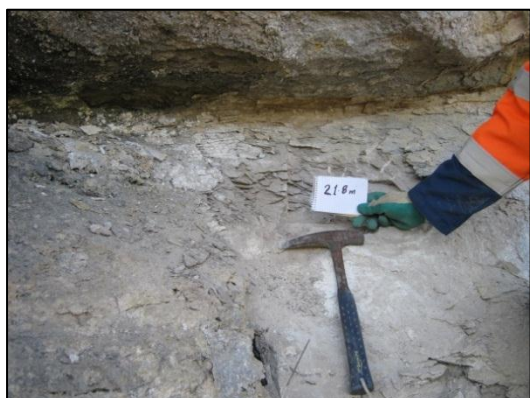
- The massive and strong limestone above 118m is shown in Figures 6.10 to 6.12, and the partially slaked and well-bedded 300mm thick mudstone exposure in Figures 6.13 and 6.14.

**Figure 6.13: Mudstone (300mm thick).**

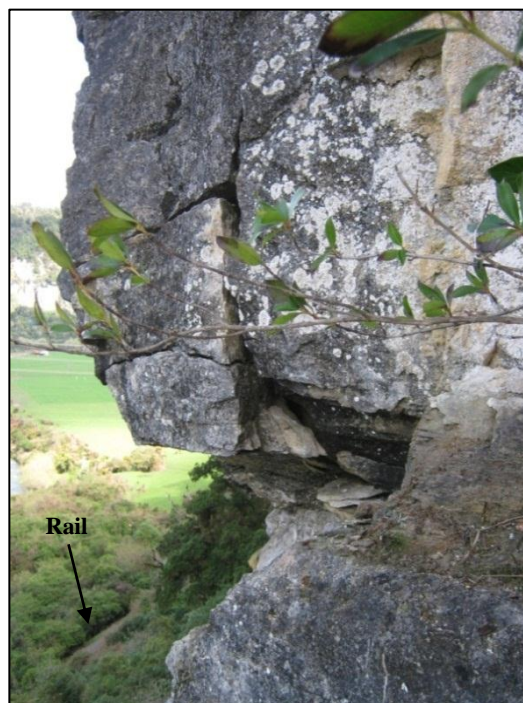
- A second 300mm thick laterally continuous grey mudstone is present at 105m, and some bedding release of limestone blocks about 1m<sup>3</sup> in volume becomes evident at about 85m (Figure 6.16).

**Figure 6.16: Cliff-face profile from ~85m elevation, view west across the rail corridor (indicated by arrow).**

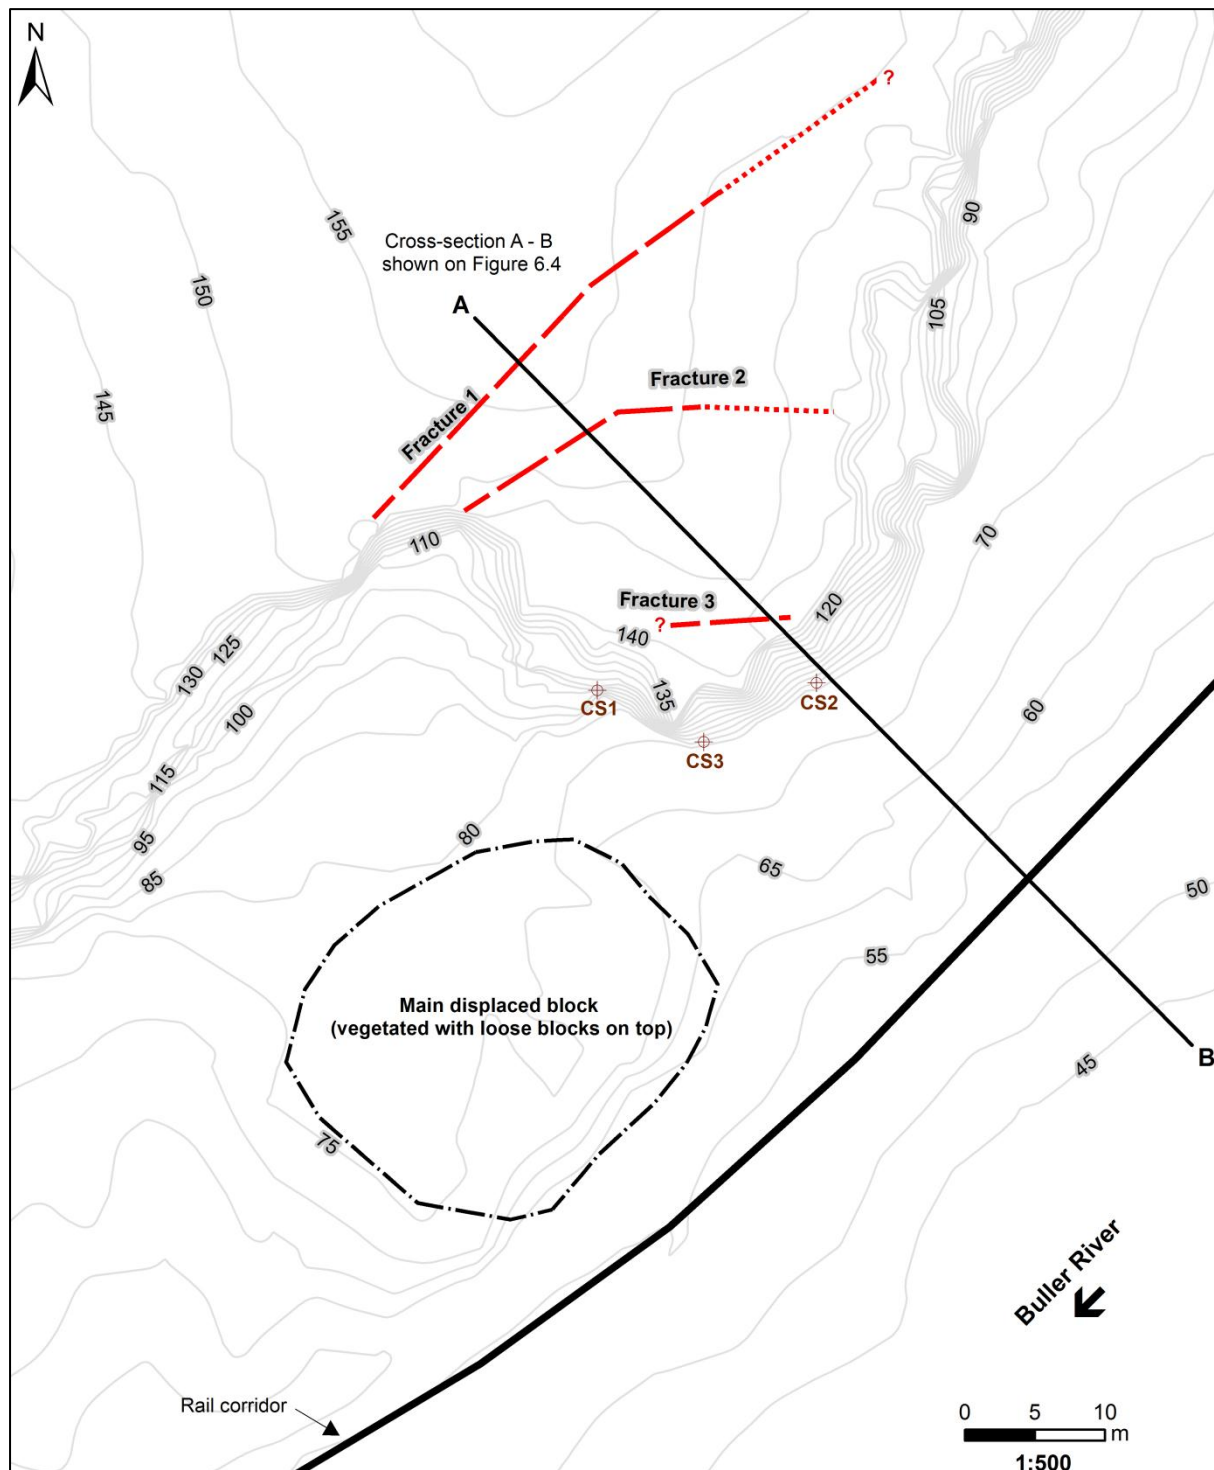
- **Core sample CS1:** recovered from the sedimentary breccia at the base of Profile W1 (Figures 6.4 and 6.17). Core recovered was not intact and not scheduled for testing.
- **Core sample CS2:** recovered from a similar stratigraphic position on Profile W2. Samples were prepared for testing, including porosity, density, seismic velocity and UCS determination without strain measurement.

- **Core sample CS3:** recovered from the same stratigraphic position (close to the sedimentary breccia contact with the overlying limestone), approximately equidistant between CS1 and CS2 (Figure 6.17). The same analytical testing was conducted as for CS2.

**Figure 6.17: Location of core samples CS1 to CS3**

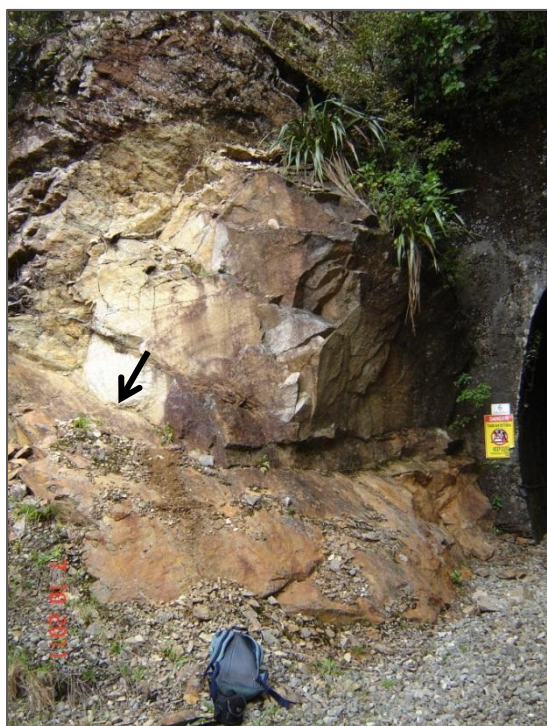
**Figure 7.2: Outcrop at SNL124.208km (eastern portal of Tunnel 6) showing granite overlying weakly foliated Greenland Group rock. Contact is arrowed.**

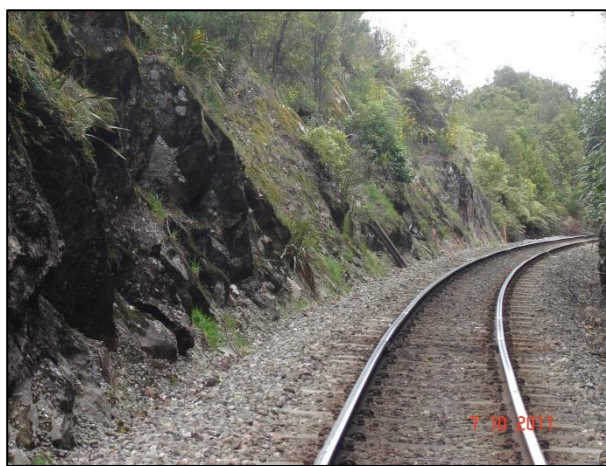
**Figure 7.3: Box cutting near SNL125.50km in metamorphosed Greenland Group bedrock.**

Based on the observations made at Te Kuha, xenoliths of Greenland Group have been incorporated into the granite at a number of locations and show significant recrystallisation to a mica-schist. The main exposure occurs within a 70m long box cutting between SNL124.470 and 125.540km, as shown in Figure 7.3.

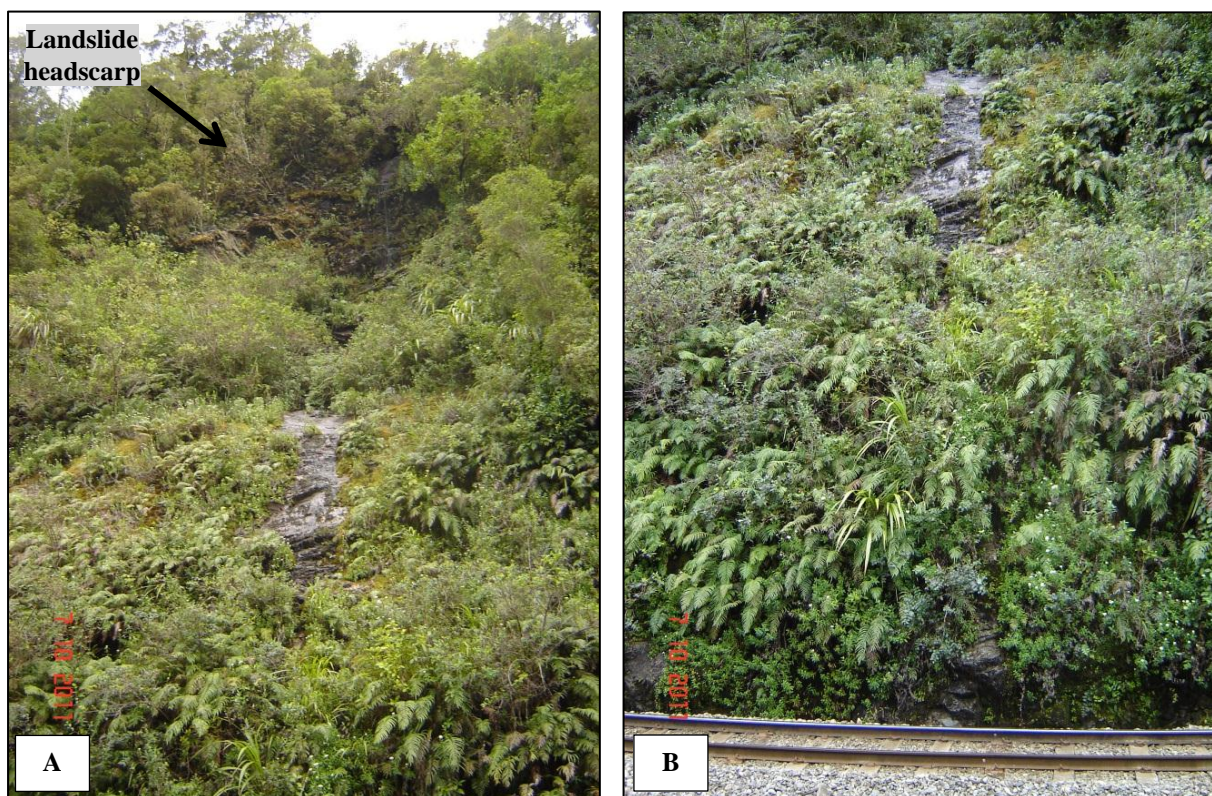
**Figure 7.12: Views of landslide near the western portal of Tunnel 6 (~SNL124.26km), including the landslide headscarp (A) and close proximity to the rail (B).**

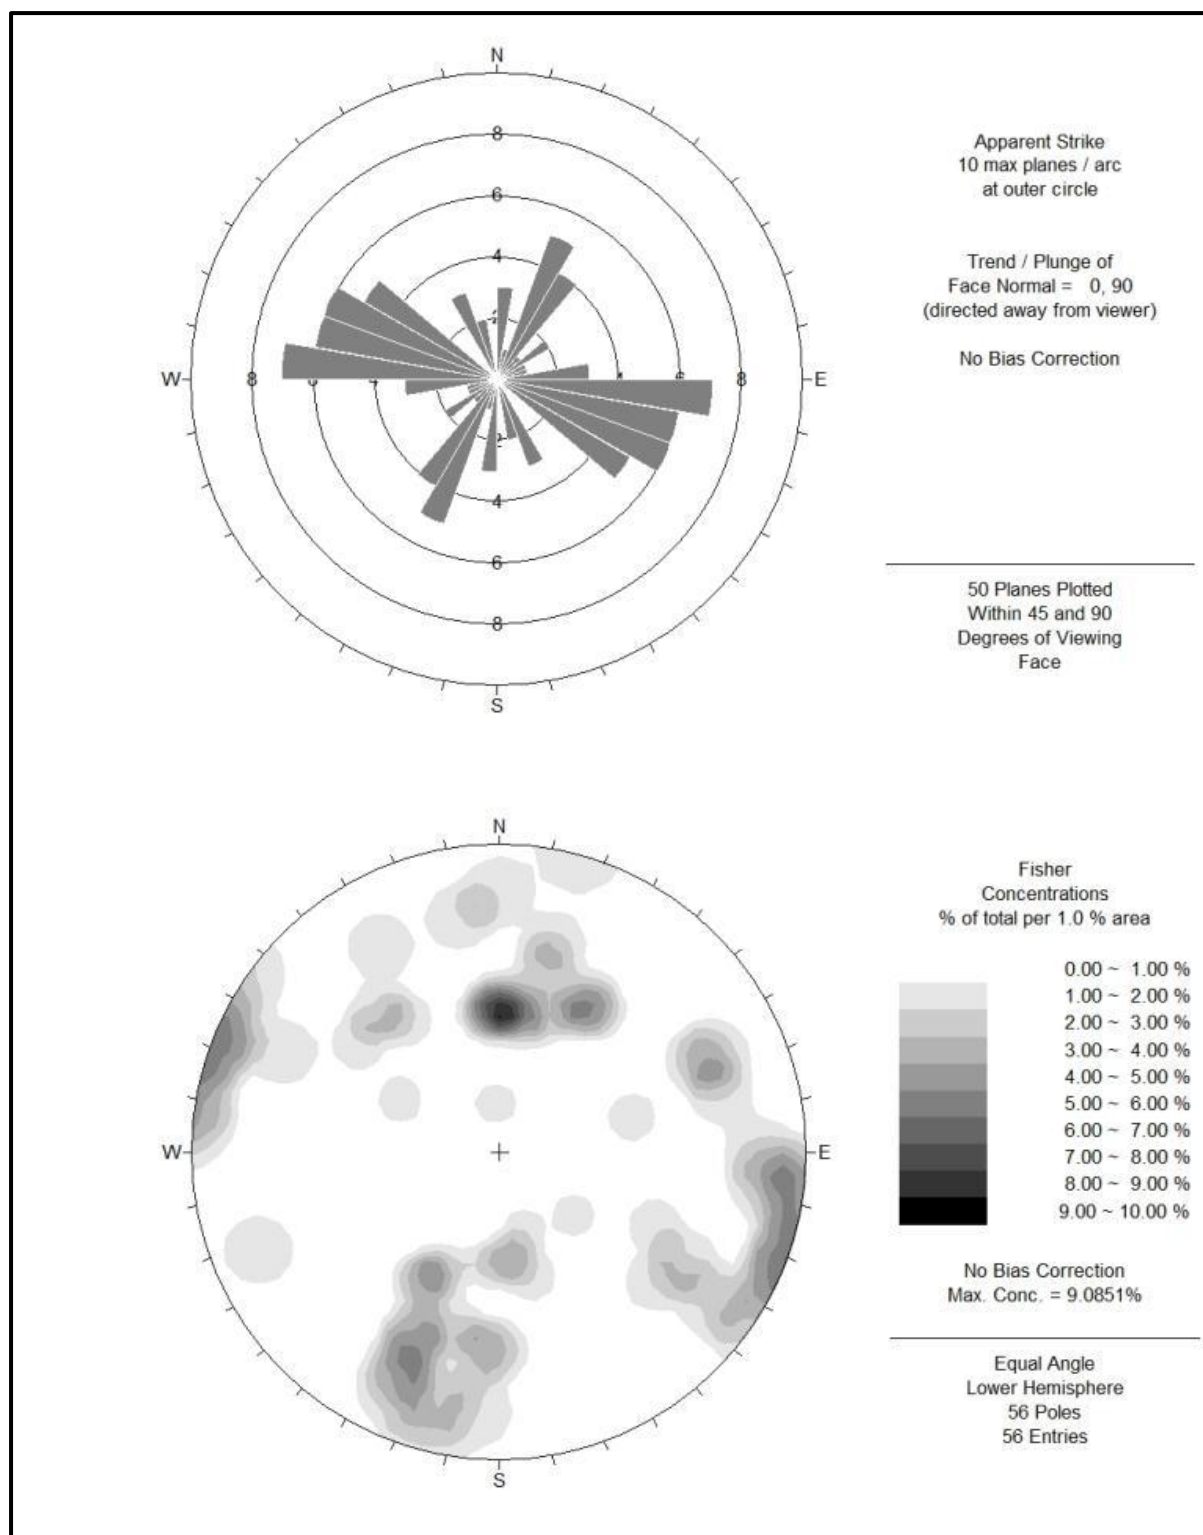
The maximum pole concentration of 9.8% relates to Joint Set 3, which strikes sub-parallel to the track (270°T) and dips downslope at about 50°. This is the primary block release surface. Joint Set 2 is a steeply-dipping ( $\geq 75^\circ$ ) defect set striking approximately normal to the track, and Joint Set 1 dips at 60° back into the face, but in a similar strike orientation to Joint Set 3. The clustering of the poles to these three orientations over the 2km length of rail corridor that is being assessed confirms the single population of rock mass defects between SNL124 and 126km.

Rock mass characterisation has confirmed the importance of the dominant defect sets in controlling block release onto, or adjacent to, the rail corridor, with the generally strong intact rock surface acting to release colluvial or regolith materials, together with some loosened joint-controlled rock debris. An estimated ~56% of this 2km rail section is considered vulnerable to future small-large, shallow translational debris slides, and localised flows.

Figure 7.14: Defect orientation (joints) between SNL124 and 126km.

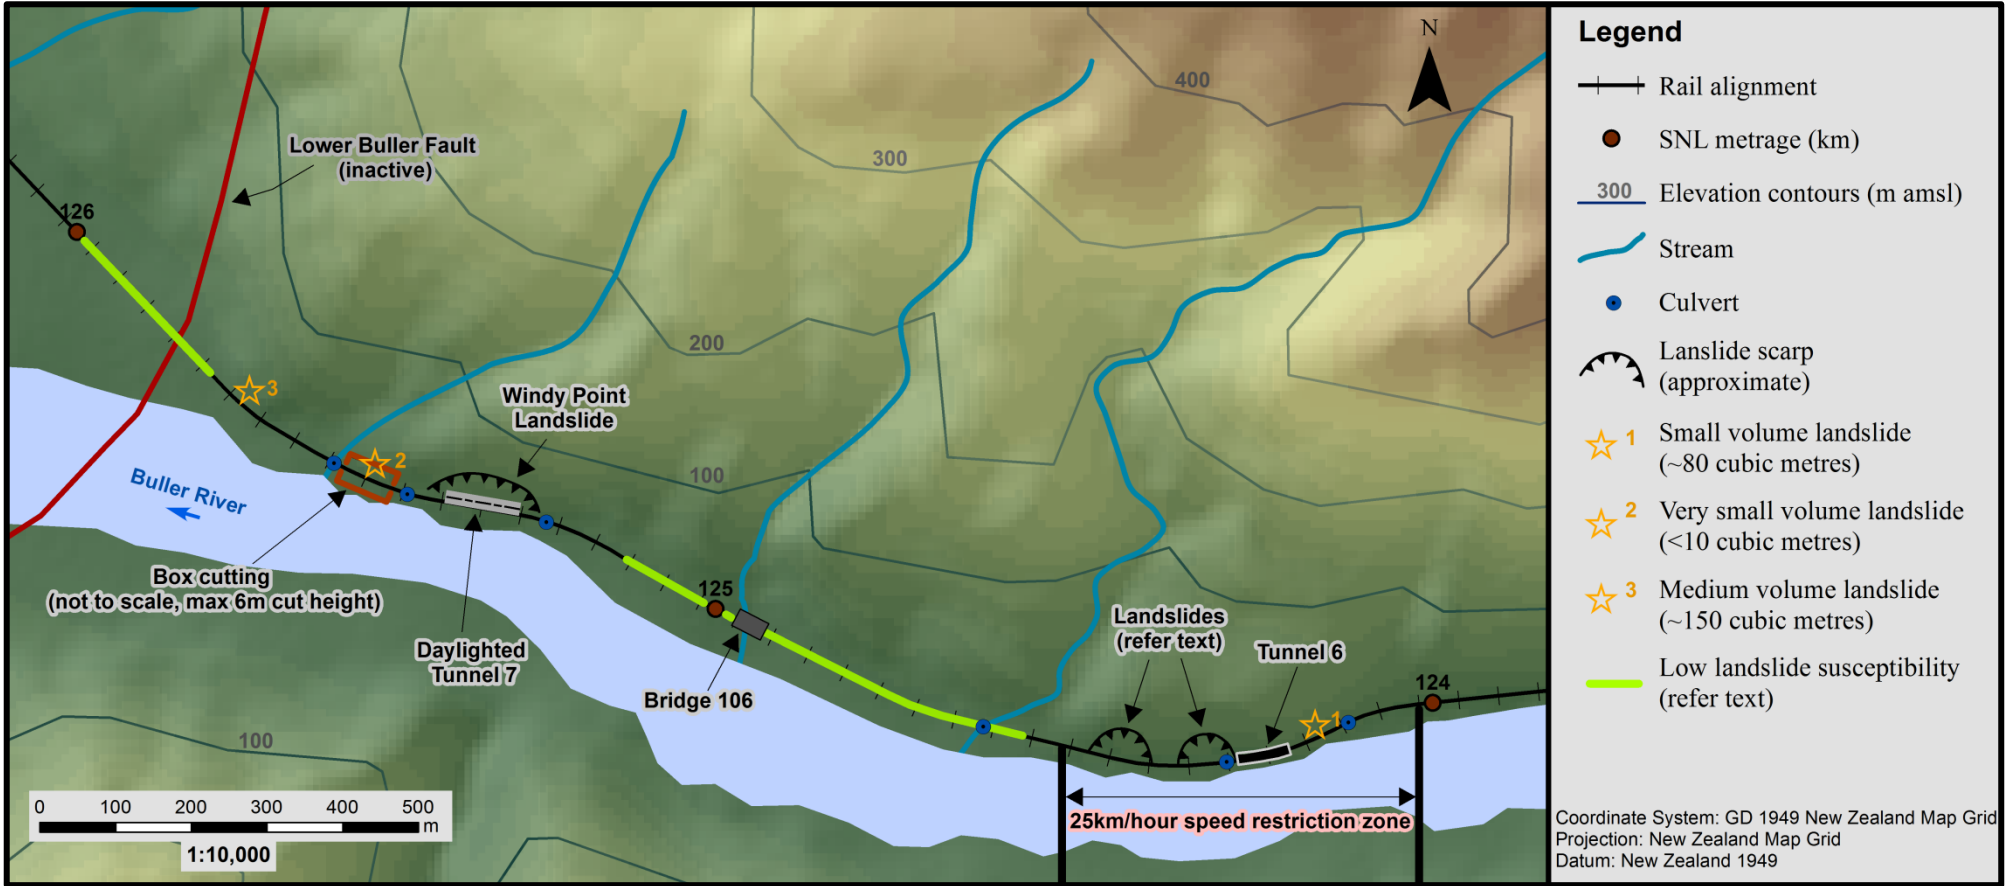
Figure 7.17: Te Kuha site model between SNL124 and 126km showing the 25km/hour speed restriction zone, landslide occurrence, infrastructure features and areas defined as ‘low landslide susceptibility’.

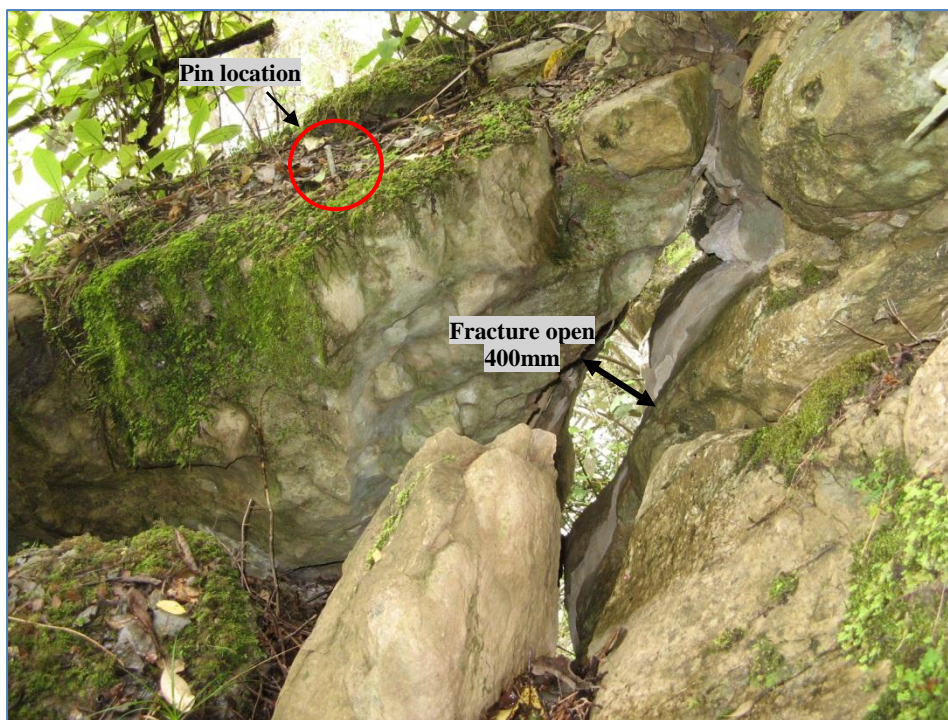
Metal pins are located across selected displaced limestone blocks at the top of Whitecliffs for the purpose of monitoring any gradual movement over time. Figures 1.3A and 1.3B show the typical environment at the top of Whitecliffs where the pins are located, marked with metal tags. Displacement monitoring has generally been undertaken annually since December 2001, with the first monitoring round conducted in January 1993. A tape measure is used to measure the distance between the centres of each set of pins. A summary of the measurements taken to date is provided in Table 1.3A, which indicates there was no gradual block displacement between January 1993 and February 2011. The method adopted for the monitoring has an error of up to approximately  $\pm 14\text{mm}$ , with results more typically in a range of  $\pm 1$  to  $6\text{mm}$  between monitoring rounds.

The frequency of monitoring and absence of telemetered information will not enable an early warning of large scale cliff collapse but has been useful to show that the seemingly precarious blocks at the top of Whitecliffs are relatively stable under current environmental and climatic conditions for at least the past 18 years.

**Figure 1.3A: Top of Whitecliffs (elevation ~140m above mean sea level). Limestone block displacement monitoring location**

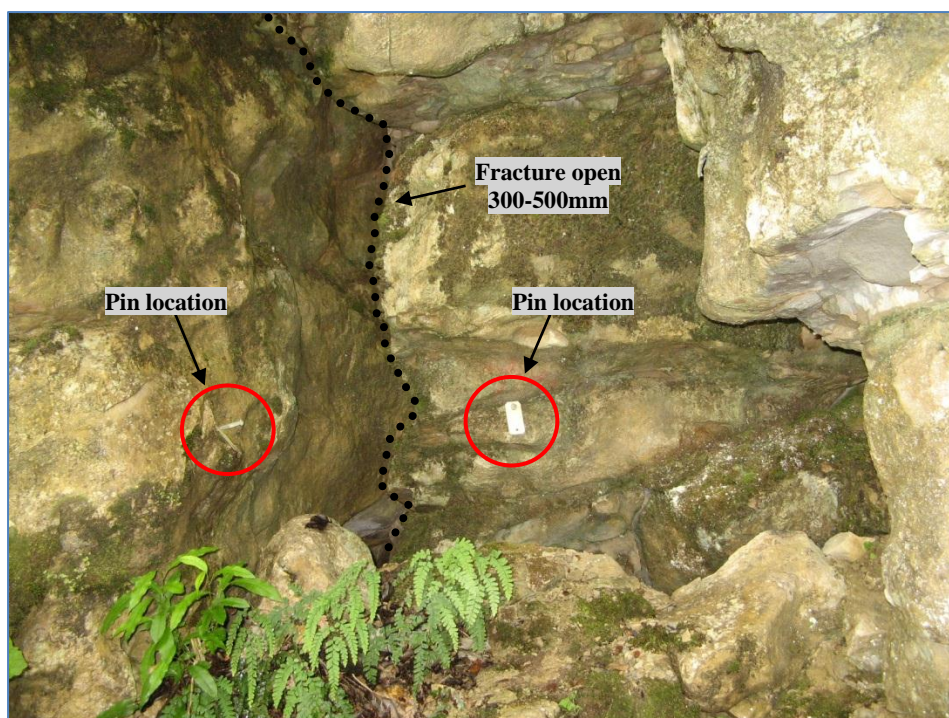
**Figure 1.3B: Limestone block displacement monitoring location**
